TECHNICAL REPORT
DUAL PURPOSE COMMUNITY
FALLOUT SHELTERS
200 & 1000 PERSONS

DUAL PURPOSE COMMUNITY FALLOUT SHELTERS
200 and 1000 Persons

15 October 1964

PROTECTIVE STRUCTURES DEVELOPMENT CENTER
JOINT CIVIL DEFENSE SUPPORT GROUP
OFFICE OF THE CHIEF OF ENGINEERS/BUREAU OF YARDS AND DOCKS

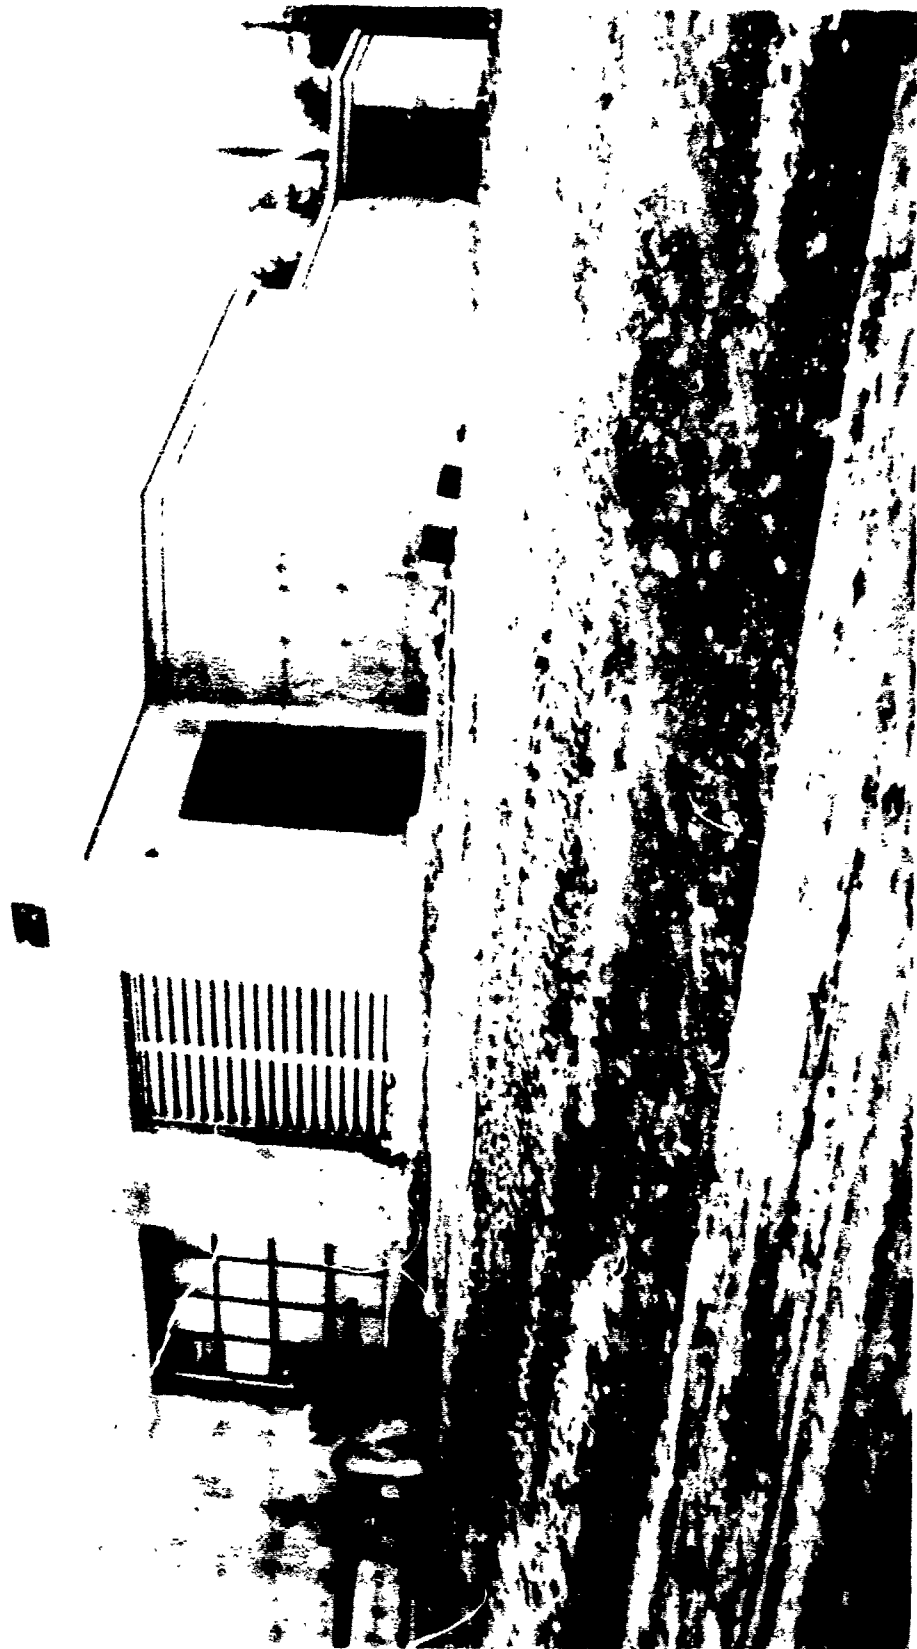
Figure E.3 Installing filters at 1000-person shelter. U.S. Army Photograph

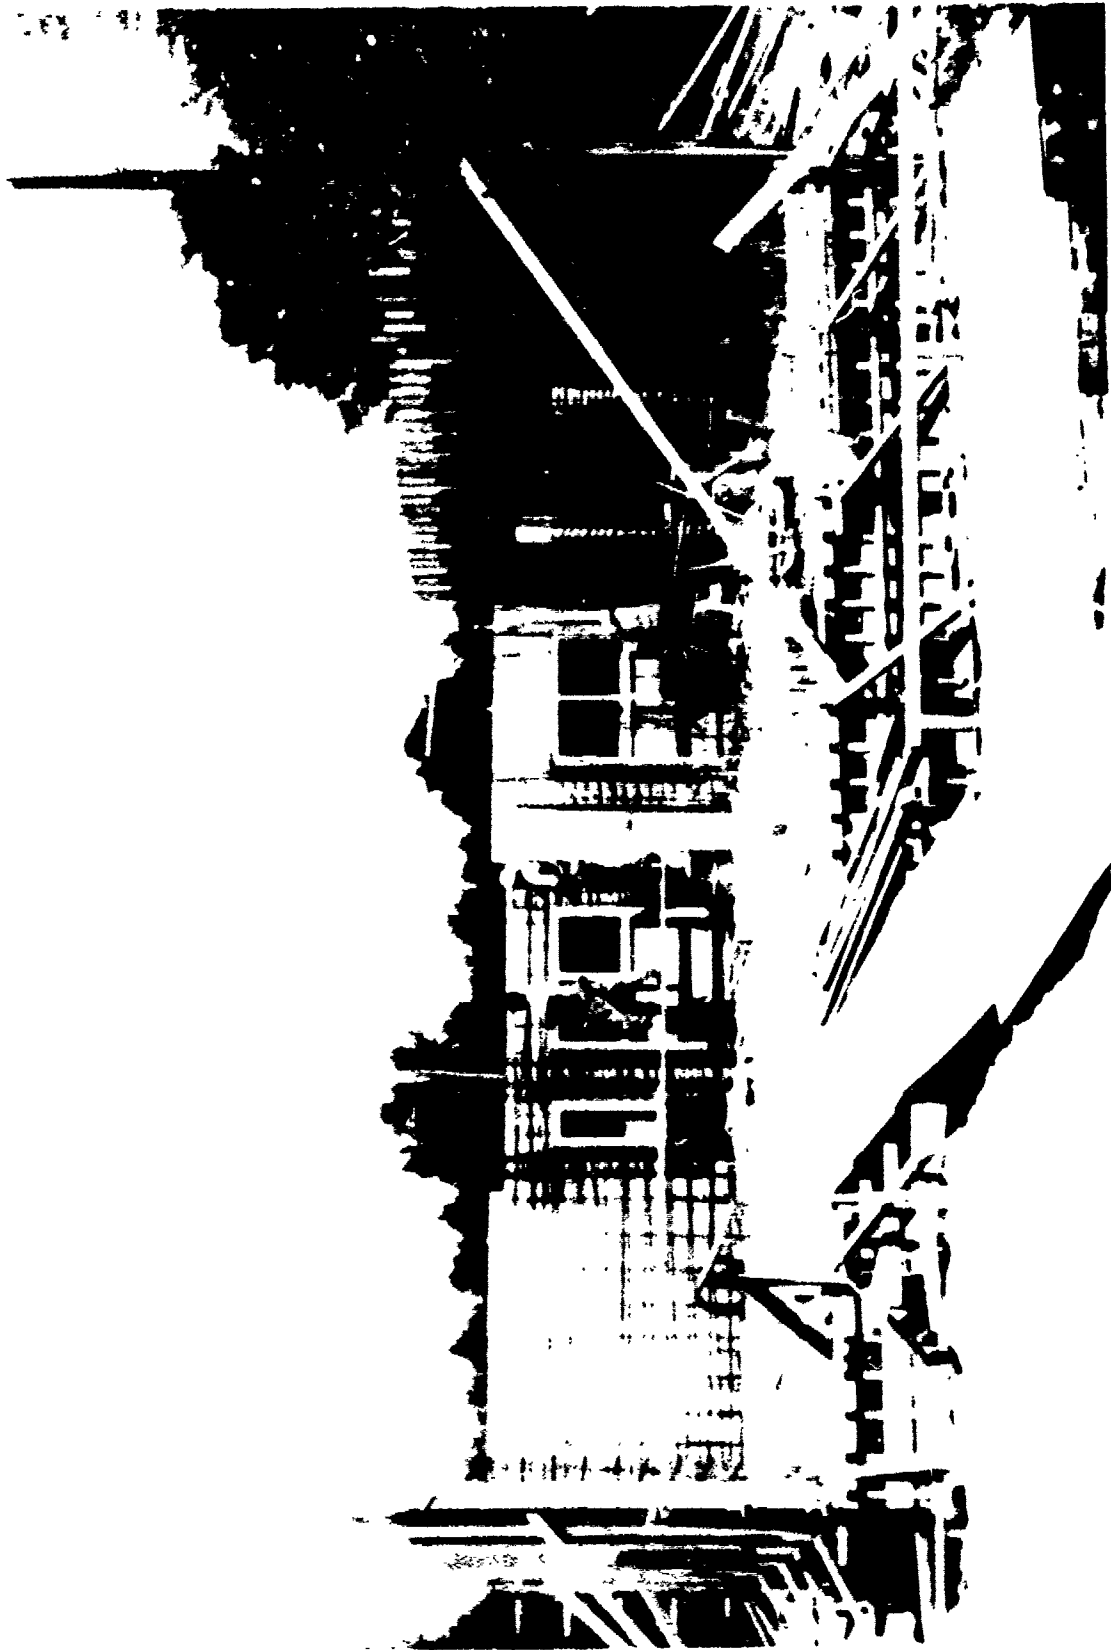
Figure E.5 Placing reinforcing steel at 200-person shelter.
